Property Inspections

Report # : SAM 4/21/2003

Subject Property
1234 Main Ave
Oceanside, GA 30066

GROUNDS

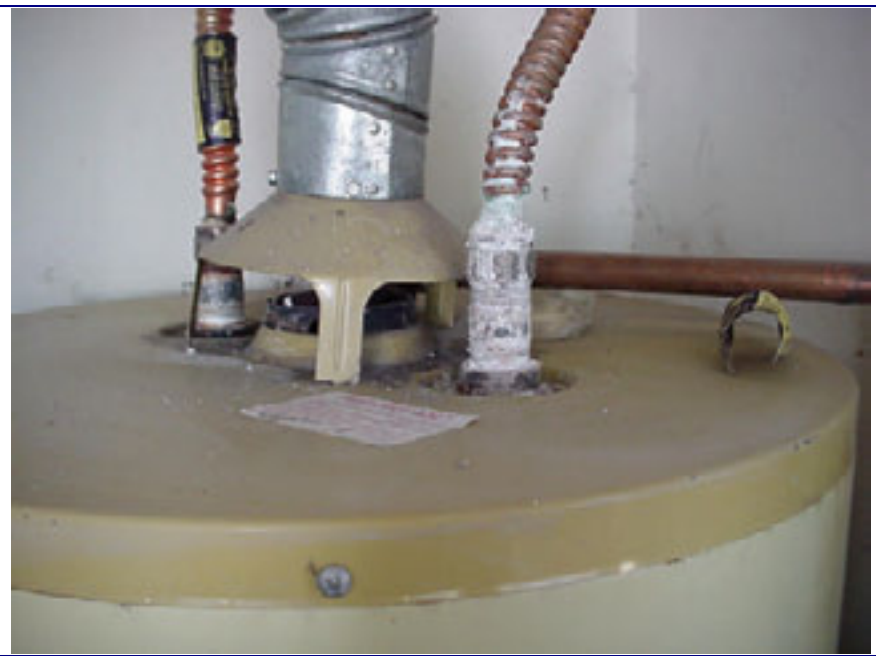
Picture 2

Bad Inlet Valve
